## **PREVENCIA NEBLAHÉHO VPLYVU DAŽĎOVEJ VODY NA OPORNÉ MÚRY ESCARP NA HISTORICKOM HRADE SÁDEK**

### **PREVENTING THE CALAMITOUS EFFECT OF STORM WATER ON THE RETAINING WALL ESCARP ON THE HISTORIC CASTLE SADEK**

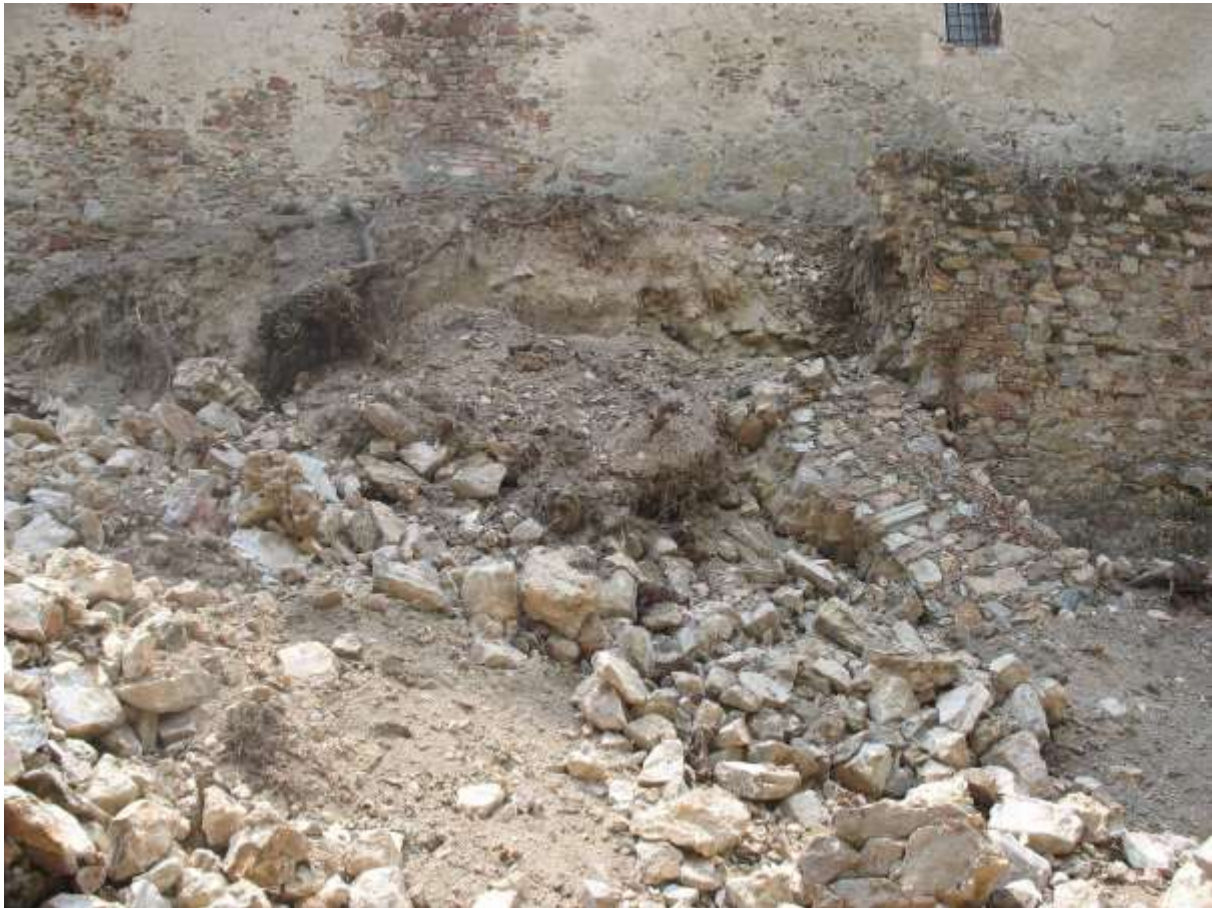
**Fig. 2:** Eskarp collapse of a retaining wall on the north side of the ditch  
(From: Ing. Michal Vondrák, 2012)

In times past and now are mostly drained rainwater from the roof with gargoyles in the castle moat, it covers the eastern part of the roof facing the ditch, and with a down pipes that carry rainwater from the roofs of most oriented to the courtyard. The draining pipe is brought to the surface esкарp where water flowed freely and seeping into the body esкарp. The western half of the roof facing the castle moat has mounted gutters and rainwater flow down freely to the surface esкарp. This solution works only in the short term and conditions prior to adjustments and clearing works in the ditch. In the long term are evident erosion and destructive effects of rainwater on retaining walls esкарp. This situation worsened after the removal of trees from the moat and surface esкарp. The root system of trees with their retention capacity contributed to the reduction effect of rainwater on the design esкарp. Another factor is deteriorating badly chosen method of repair of retaining walls in times past, where it was used impermeable mortar lining and so there infiltrated the accumulation of rainwater inside the body esкарp. The water pressure was the cause of many accidents. The destructive process of retaining walls esкарpy accelerated by the aforementioned removal of trees from the trench and surface esкарp. It was therefore necessary to resolve the question of rainwater as quickly as possible to avoid further problems.

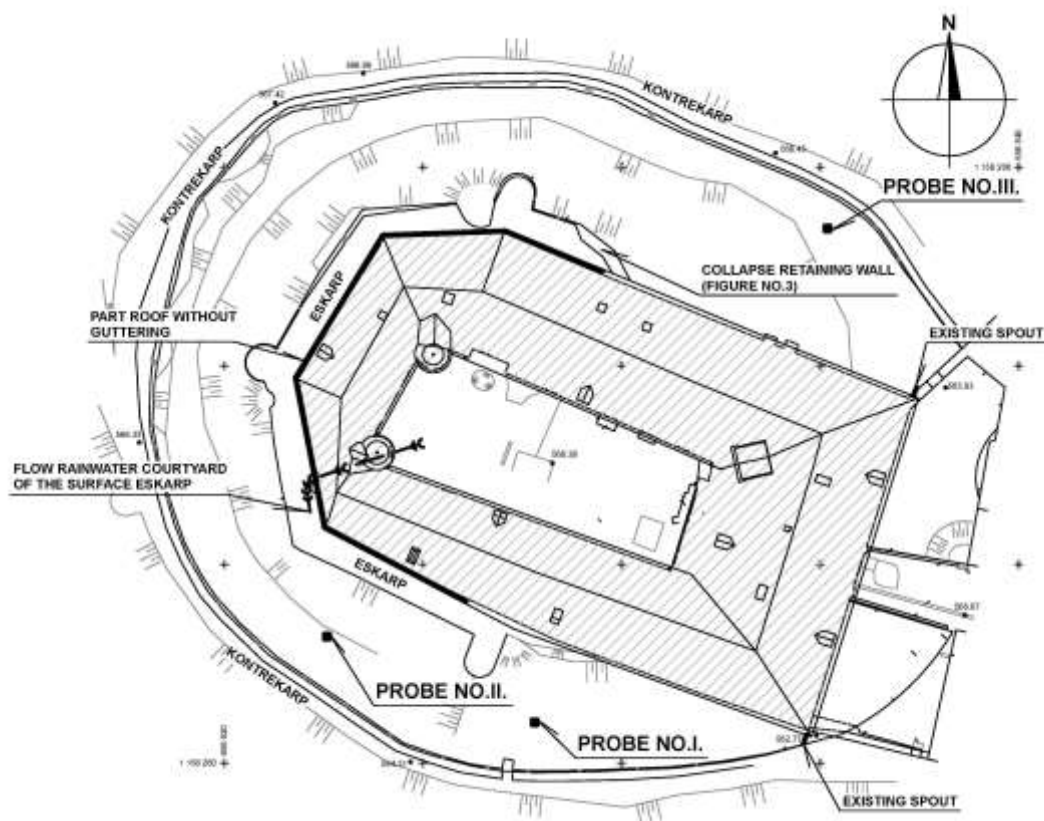
**Fig. 3:** Plan of the castle Sádek  
(From: Ing. Michal Vondrák, 2013)

- necessary to prevent the inflow of rainwater from the roof to the surface eskarp. This will be achieved by fitting rooftop gutters around the outer perimeter of the building, ie. add gutters on the west side. Following the Roof drains will be constructed drainage nerve-block anesthesia in the body eskarp to be drained into the ditch.

- Eliminate subsidies seduced rainwater from the court to the surface eskarp. Currently wastewater is led in the western passage of the object, resulting in distortion of the retaining wall and the erosion of the surface. It was designed to seduce the western part of the building, including newly created downpipes to seepage facility located on the south side of the ditch. I suggest underground infiltration devices coated with grasslands or sandy paths by finishing.

- It is also necessary to prevent the free discharge of the gargoyles on the northeast side and thereby prevent the erosion effects of free-falling water on the treated surface. I suggest to replace the gargoyle rain drain pipe and together with the newly established

deception on the north side of it connected to the infiltration facility located on the north side of the ditch. Infiltration devices suggest an underground coated grasslands or sandy paths.

- The existing gargoyles on the southeast side will be given to maintain the architecture, it needs to extend only to avoid the impact of rainwater into the ditch, or for low flow.
- rainwater from the roof in the eastern part of the yard, I propose to bring into existing underground tanks, where they used to use for toilet flushing, irrigation, or for use according to the needs of the owner.

Withholding water will be concentrated seepage, and in two underground infiltration devices mounted in the moat. Now we come to the fact that it is necessary to determine the permeability of soil to design the infiltration device. When designing the applied procedure in the long-awaited ČSN 75 9010 - Infiltration devices rainwater.

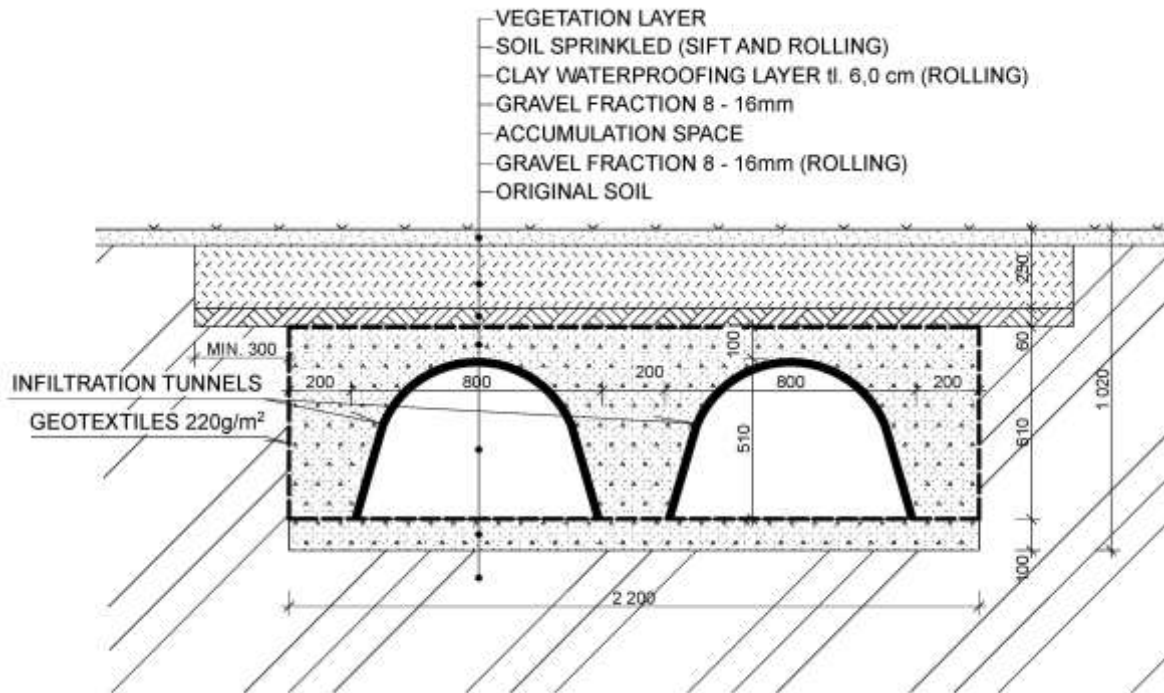
Coefficient were used in the design of infiltration devices. Storage space infiltration device consists infiltration plastic tunnels that will be stored on compacted gravel sub-base fraction 8-16 mm with a thickness of 10cm. The gravel layer will be laid before laying tunnels geotextiles weighing 220 g/m<sup>2</sup>. The tunnels will be backfilled with gravel, then the same faction as the subbase. The whole body is wrapped gravel geotextile. Above infiltration object must be a minimum cover layer of soil of thickness. 25 cm. To avoid drying up of vegetation over the device, it is necessary above the gravel backfill wrapped in geotextile layer of clay deposit of min. ply 5 cm. Rainwater objects must always be vented through vent chimney located on the opposite part of the device which is a tributary.

**Fig. 4:** Type cut infiltration device  
(From: Ing. Michal Vondrák, 2013)
